A fire resistance test performed on a specimen of a non-loadbearing composite wall assembly utilising the heating conditions and performance criteria of ASTM E119-14

351645

**Alstrong Enterprises
India (PVT) Limited**

15th June 2015

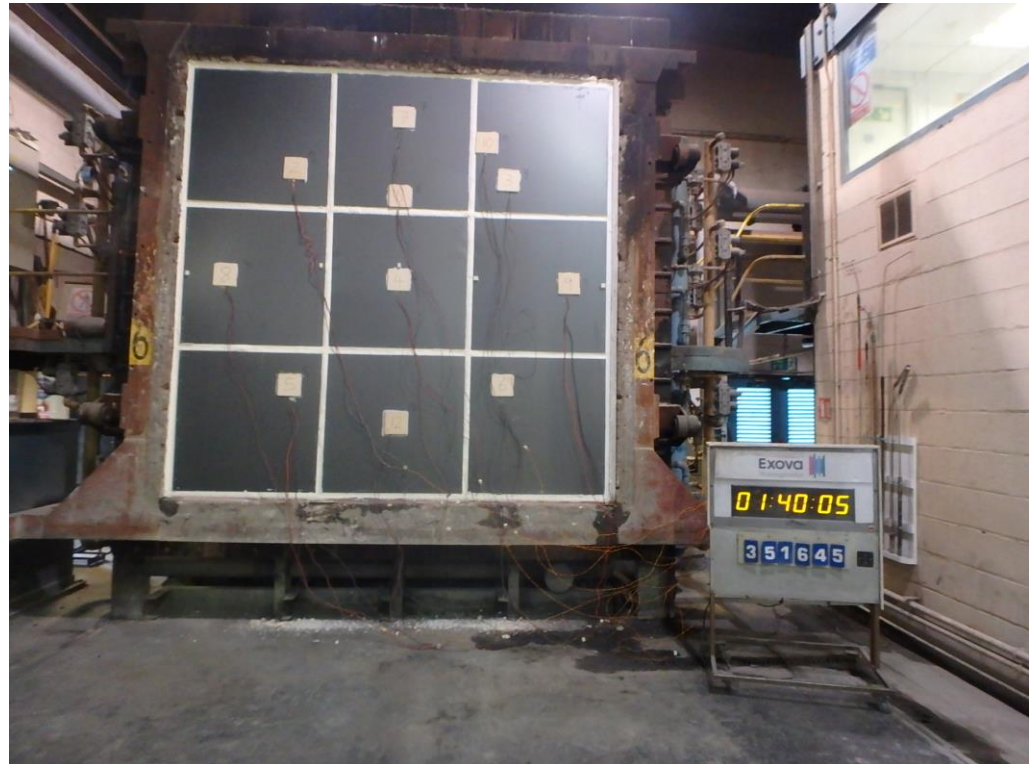
Time		
mins	secs	
87	55	The assembly continues to deflect towards the furnace chamber at its centre now by approximately 65-70mm.
91	50	Smoke/steam release across the bottom perimeter edge of the central panel has stopped as the intumescent material continues to expand causing the separation of the mastic to the panel edges to close back up.
99	40	Slight undulation is evident along the vertical perimeter edges of the middle row of panels.
101	30	Viewed from the exposed face, the internal core insulation has detached and fallen away at the bottom half of the assembly between the central vertical frame posts. This is now evident at mid width of the specimen between the posts. The now exposed plaster board facing appears slightly cracked throughout.
105	05	Smoke/steam release issues across the bottom half perimeter edge of the bottom-middle panel. The middle row of panels continues to deflect and appears heavily distorted

The unexposed
face of the
assembly after 100
minutes of testing

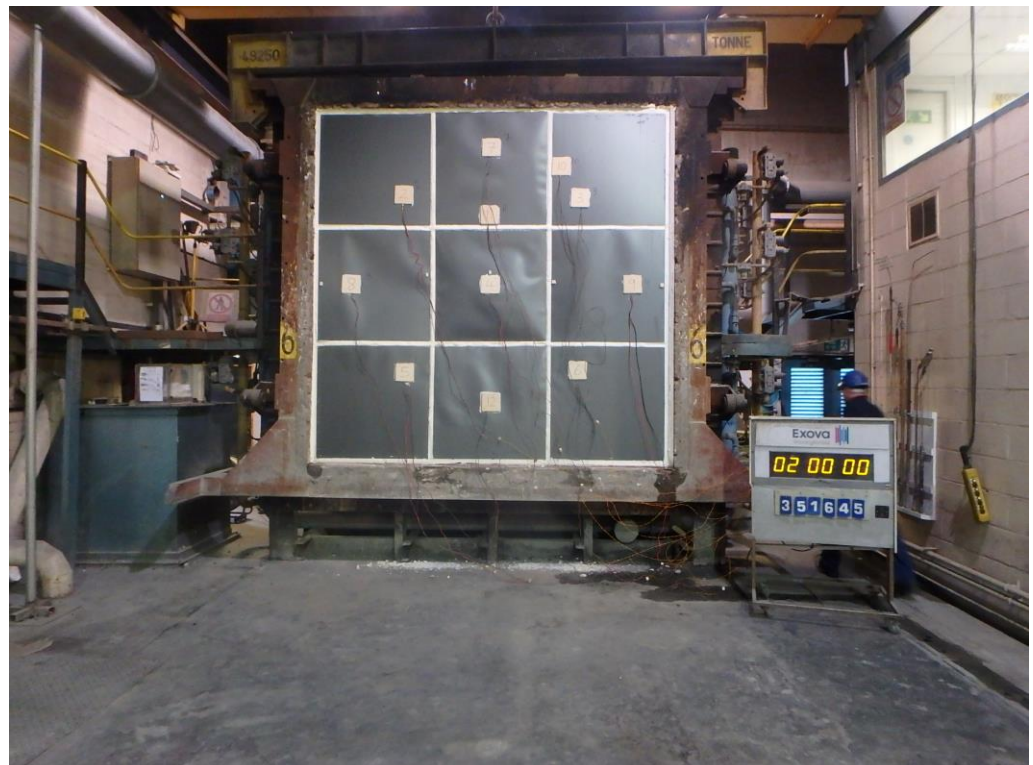
110	45	Thermocouple number 4 records a temperature rise in excess of 181°C. Insulation failure is deemed to occur.
152	06	Viewed from the exposed face, a large horizontal crack has formed within the bottom half of the second layer of board. Flames issue along the crack.
118	30	No significant visible change to exposed face.
120	00	The specimen continues to satisfy the integrity criteria. The fire resistance test is discontinued.

The unexposed
face of the
assembly after 120
minutes of testing

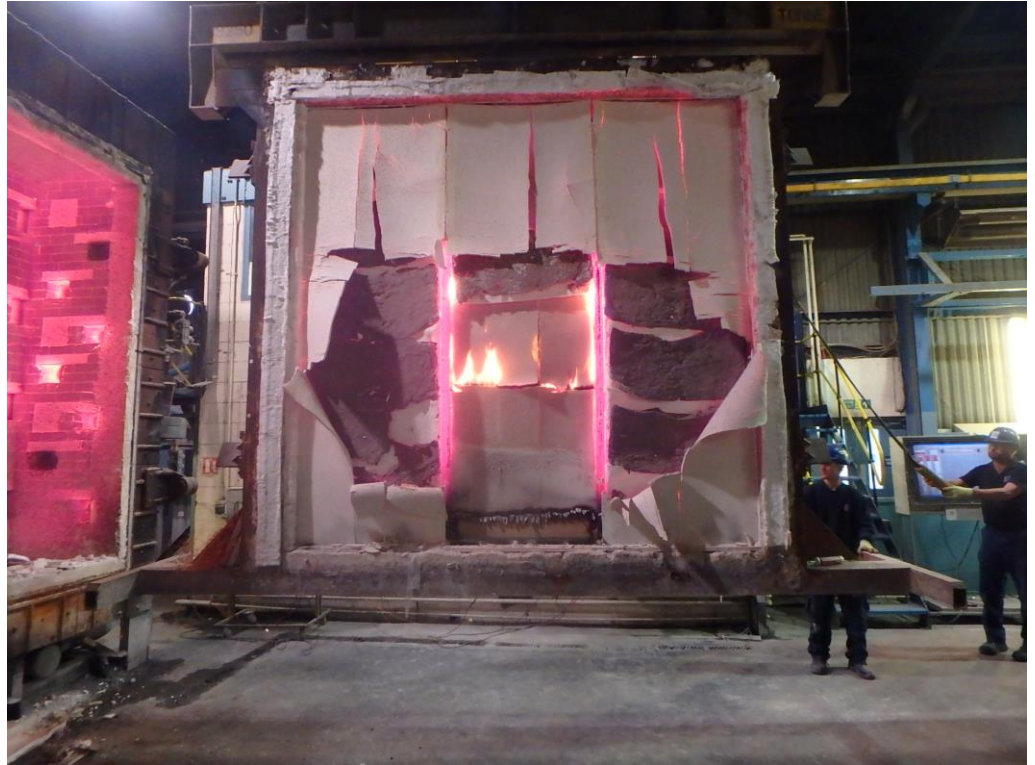
75	20	Smoke/steam release increases across the bottom perimeter edge of the central panel as the intumescent material begins to separate from the perimeter edge of the panel.
77	00	Viewed from the exposed face, the majority of the board has fallen away from the bottom half of the assembly. The steel box section framework is now visible at the bottom half of the assembly.
80	00	The intumescent material around each panel begins to swell up slightly.

The exposed face
of the assembly
immediately after
the test

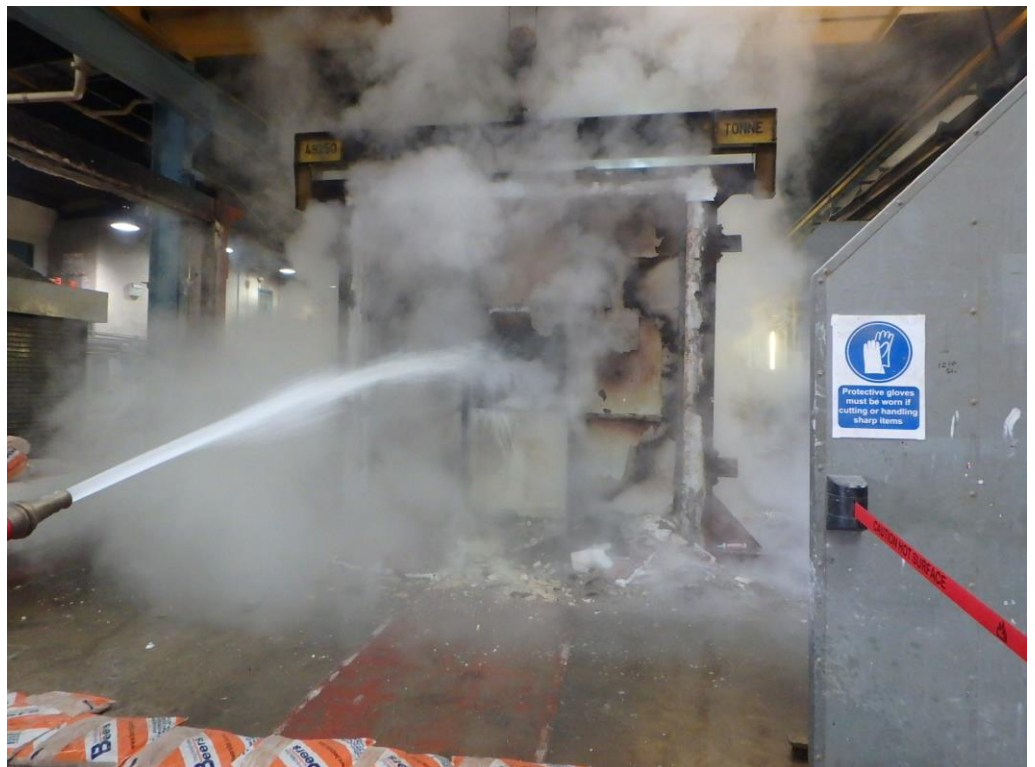
The exposed face of the test assembly is subject to a hose stream test for a 65 second duration. During the application of the hose stream, the bottom middle panel detaches from the assembly on three sides allowing water to project through to the unexposed surface of the specimen. Therefore, the specimen is judged to have failed the requirements of this test.

The exposed face
of the assembly
during the hose
stream test

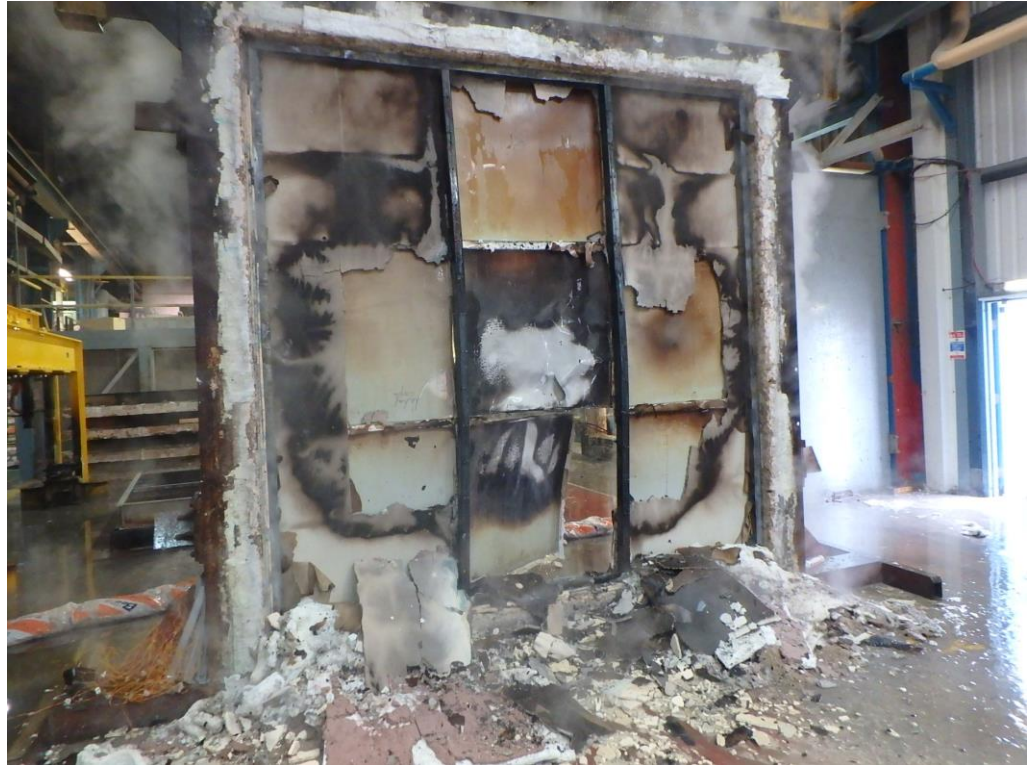
The exposed face
of the assembly
immediately after
the hose stream
test

During the application of the hose stream, the bottom middle panel detached from the assembly on three sides allowing water to project through to the unexposed surface of the specimen. Therefore the specimen was judged to have failed the requirements of this test.
